Demonstration of Thermally Sprayed Metal and Polymer Coatings for Steel Structures at Fort Bragg, NC

Final Report on Project F07-AR10

September 2017

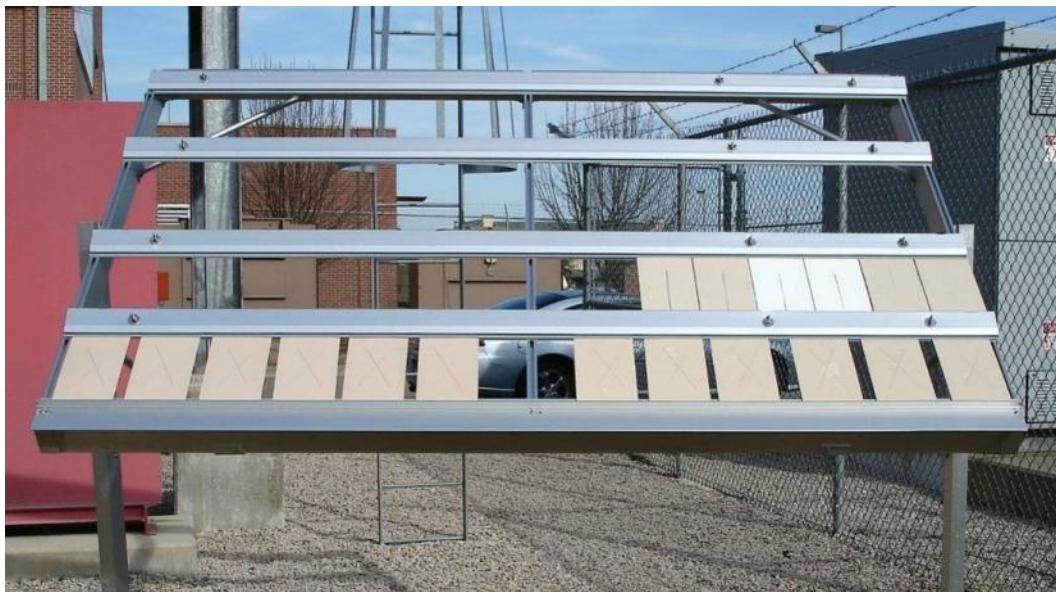
Figure 11. Exterior exposure test panels: Polyolefin coating, bottom row from left; zinc-aluminum metallized coating sealed with acrylic topcoat – bottom row, right.

Visual inspection of the exposure panels on the test rack also indicated that the coatings were providing excellent corrosion protection to the steel. Randomly selected panels were brought back to ERDC-CERL and subjected to further evaluation in the laboratory, as described in section 3.1.2.

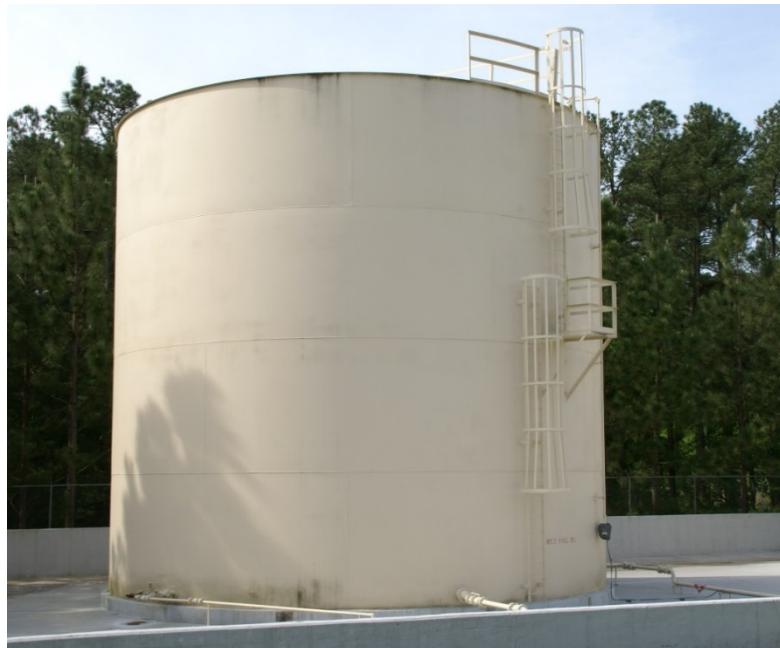
A thorough visual inspection of the heating plant's fuel tank showed that the 85/15 zinc-aluminum coating was still providing corrosion protection after 7 years exposure. Particular attention was paid to areas of penetrations and weld filets. No visible rusting was observed. Figure 12 shows the heating plant's fuel tank, as inspected.

Figure 12. Heating plant's fuel tank, as inspected on 6 May 2015.
The visible, dark areas are dirt and algae staining.

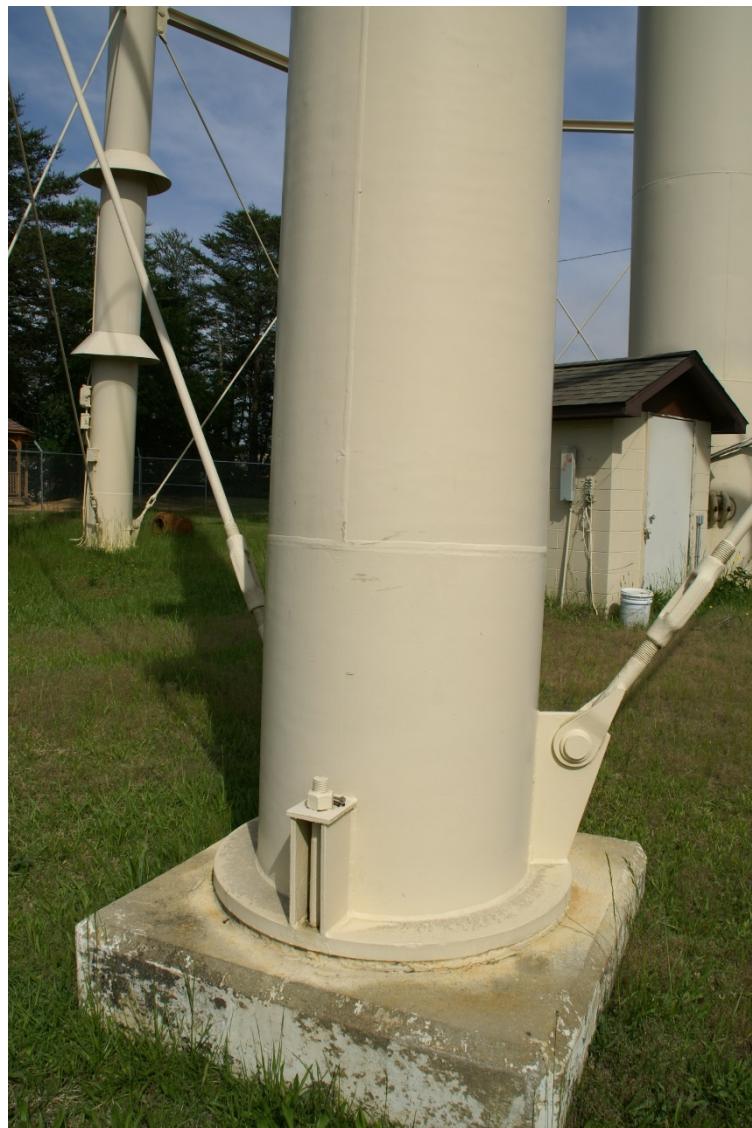
A thorough visual inspection was also performed on the elevated water tower tank's legs, showing the polyolefin coating was still providing corrosion protection after seven years exposure. Figure 13 shows one of the legs, as inspected.

Figure 13. One of the elevated water tower's legs finished with the flame-sprayed polyolefin coating, as inspected on 6 May 2015.
